Stream Team 2019

Methods and Materials

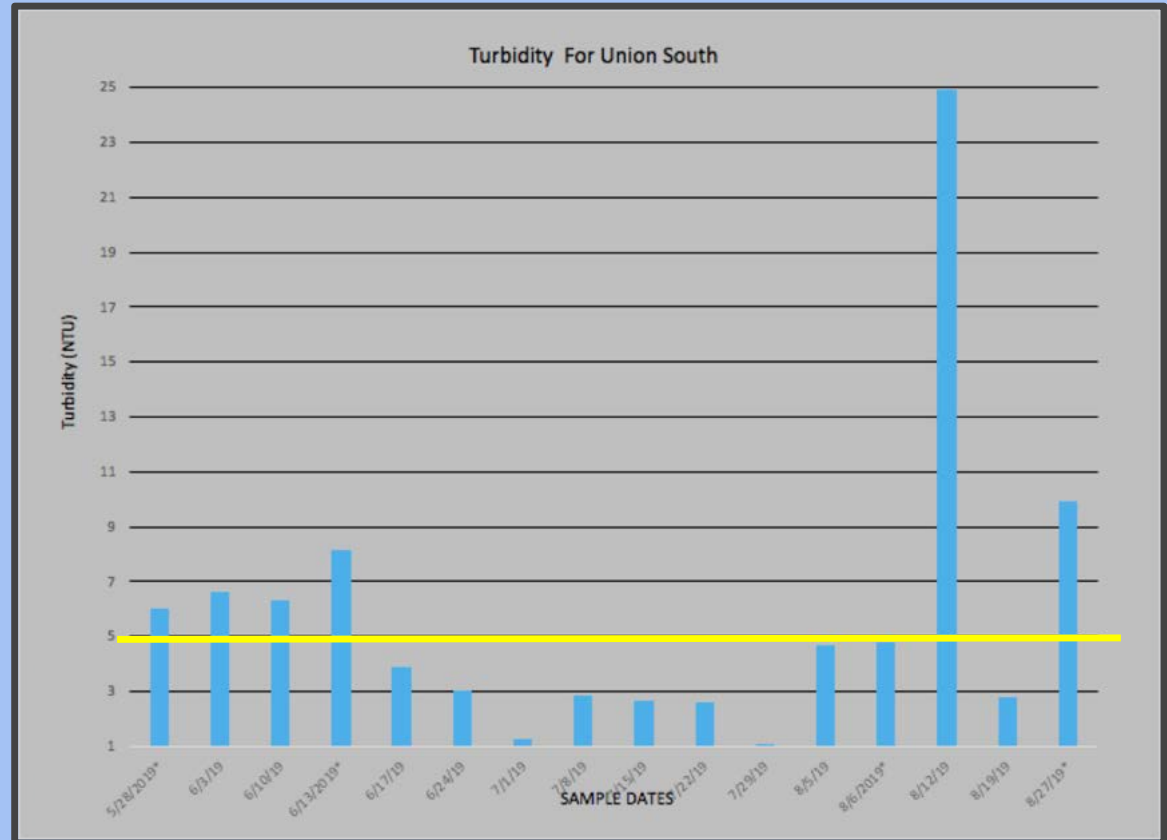
Union South Turbidity

- Too much = unsuitable for aquatic life
- Correlates well with rain events
- Turbidity is caused by dissolved or suspended particles in water, which makes water appear murky or cloudy
- Could be adding to nutrient pollution
